HOWBURY MOATED SITE

REPAIRS TO THE REVETMENT WALLS ABOVE AND BELOW WATER

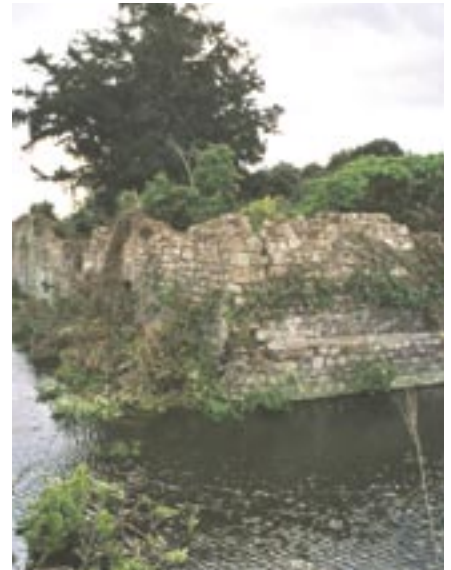
BEFORE

Close inspection, including an underwater diving survey carried out by the Port of London Authority Diving Team, showed that underwater repairs were required to ensure the longevity of this ancient monument.

The project included underwater pointing by divers and corner stitching above the water using stainless steel bars, grouted into the substrate. Also, traditional repairs by stonemasons were undertaken, using salvaged ragstone from another site, with non-hydraulic lime mortar.
